## Walkability

Emily Rae Seiler and Noah Zollner

*Millersville University is amid a planning phase for campus improvements and renovations which posed an opportunity to voice concerns about campus safety regarding the walkability of a busy section of campus. One of the areas of highest foot traffic at Millersville University is from the Southern residential core of campus, where residential and dining halls are located, to the Northern academic core, which contains most of the academic buildings. Roads outline the path of travel that the University intends students to take to walk between these cores. The shortest possible pathway—the grassy area and parking lot between the South and North end—was not designed for pedestrian travel. The University has designated crossing paths circumventing this section that were installed under the assumption that those are the pathways students will typically use. Student travel patterns were recorded to determine if this assumption was correct. By counting the number of students traveling through these areas at different dates and times, the study serves to track the volume of student foot traffic to verify if the walkability of the center of

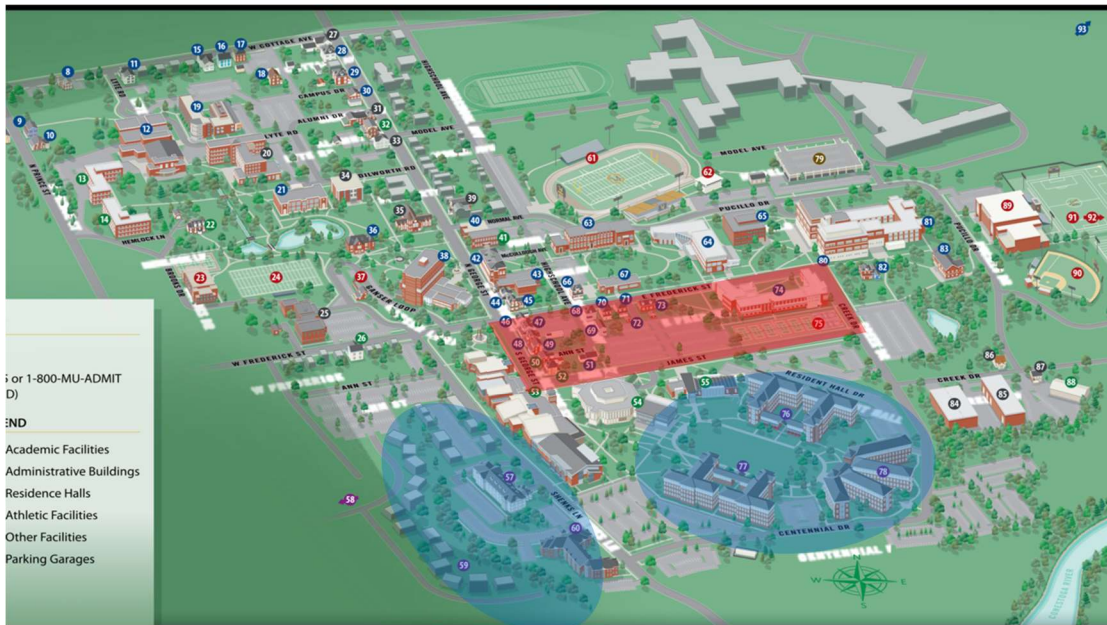
**Figure 1.** Campus layout. Residential facilities are in blue, and the observational area is in red.

Section of the American Society of Safety Professionals to voice concerns and recommendations to administration regarding proposed changes. The area of focus, highlighted in red in Figure 1 and viewed in detail in Figure 2, was chosen because it has a high volume of student traffic both by foot and by vehicle. Researchers counted the number of students who were crossing through the parking lot rather than traveling around or who were crossing the street outside of a marked crosswalk.

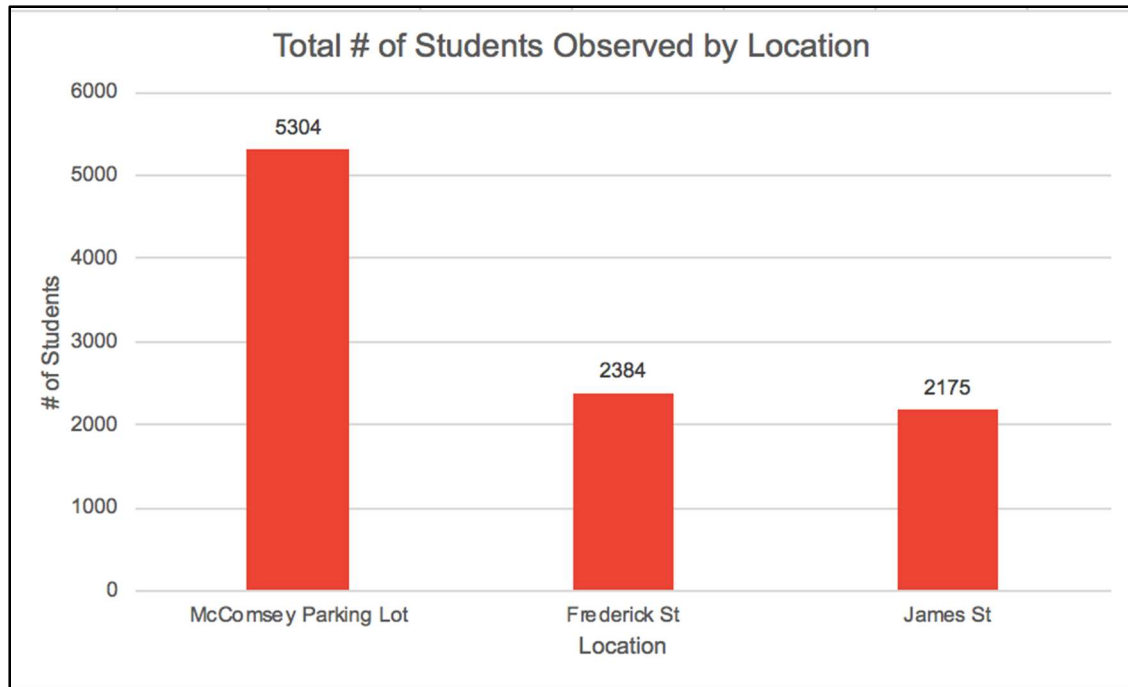
**Chart 1.** Total number of students observed by location.

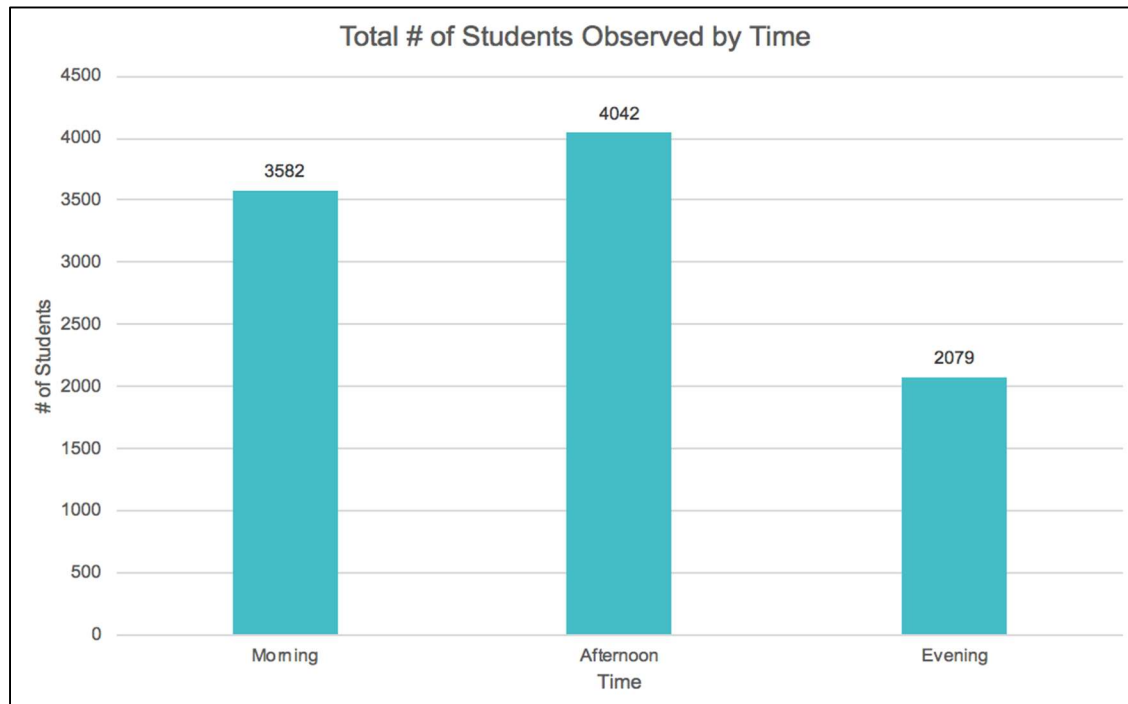
**Chart 2.** Total number of students observed by time.

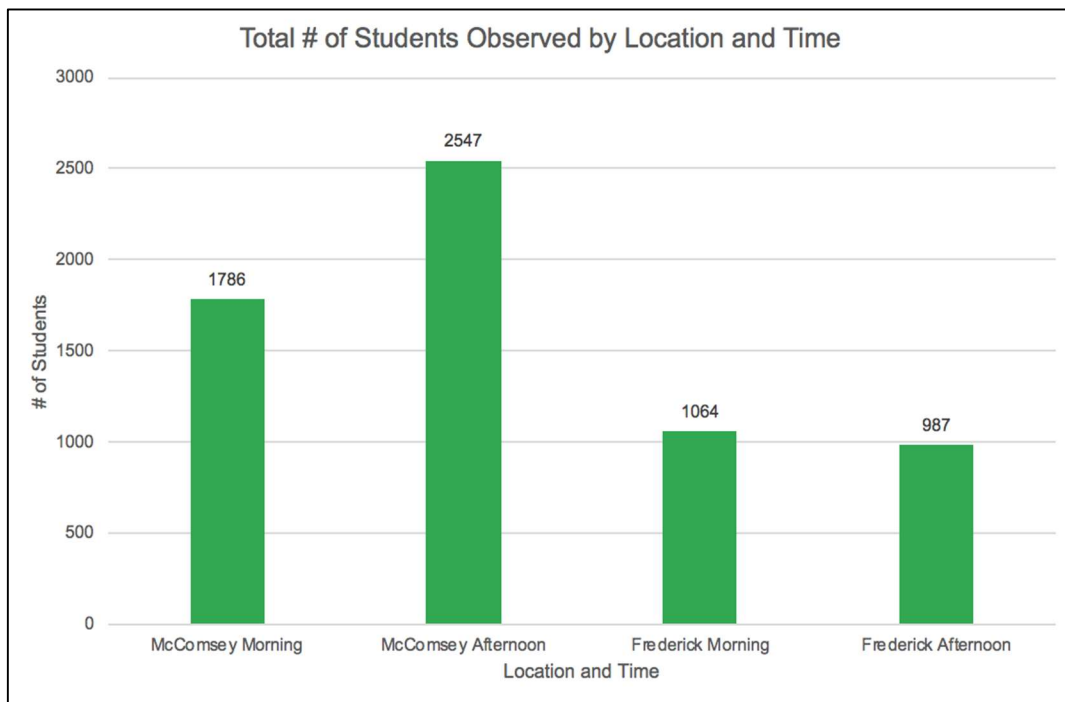
**Chart 3.** Total number of students observed by location and time.

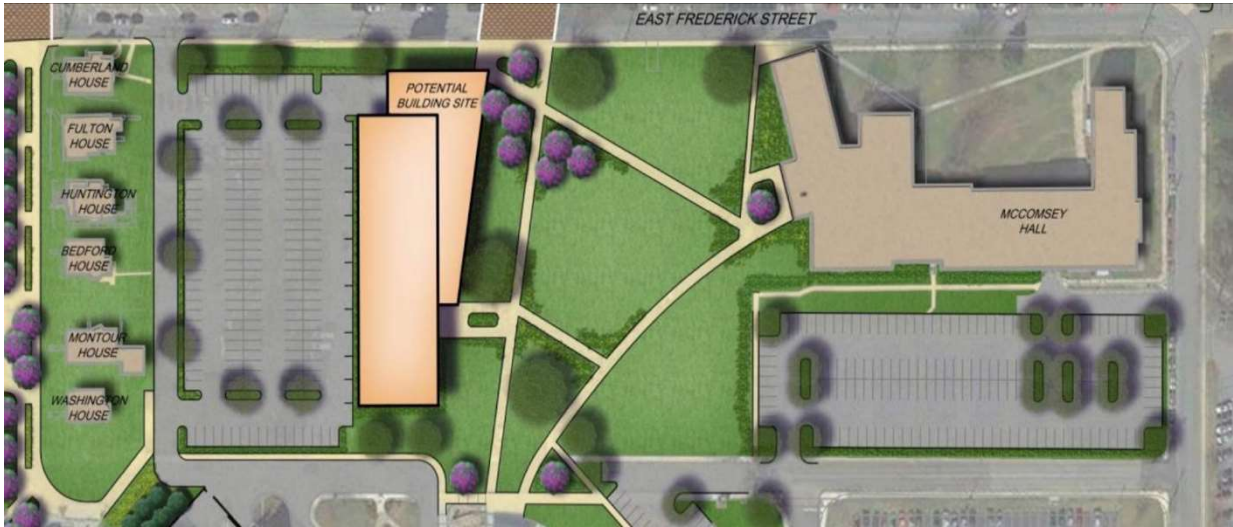
Figure 3. Master plan mockup.

A conceptual new parking lot on the left side of the mockup in Figure 3 does not eliminate the issue of poor walkability, but instead moves the problem from the middle to the left side. While the walking paths

through the center of the grassy area are an improvement, there will consistently be a pedestrian hazard while a parking lot remains in the path of least resistance from the South residential core to the North academic core.
